Ballina land-based floodgate trial

Ballina Shire
Council

Increasing
Resilience to
Climate Change

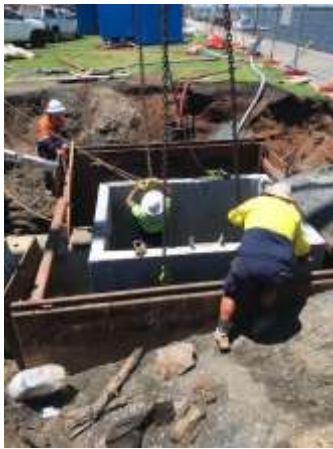
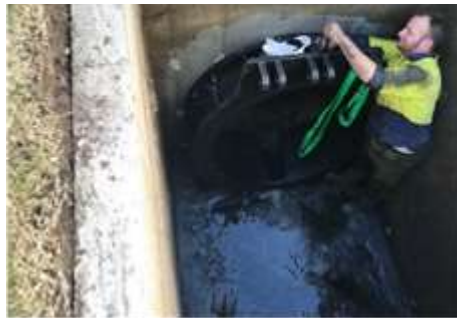
From left to right: installing pre-cast pit; installing the floodgate; the HDPE floodgate at the factory.

Traditionally, floodgates have been located at or over a water body. This project involved the construction of a land-based pit enclosure, which allows safe floodgate maintenance. The pit features a precast concrete lower section, which was easy to install.

The floodgate was made from HDPE, or high-density polyethylene. This material is strong, lightweight and malleable. The custom-made HDPE floodgate, with long-lasting stainless steel hinges, had advantages over unsuitable agricultural floodgates and costly imported options.
